AHERA Inspection

Oasis Elementary School South 3415 Oasis Boulevard Cape Coral, Florida 33914

Report Number: 23-060217-AS
Prepared On: July 6, 2023

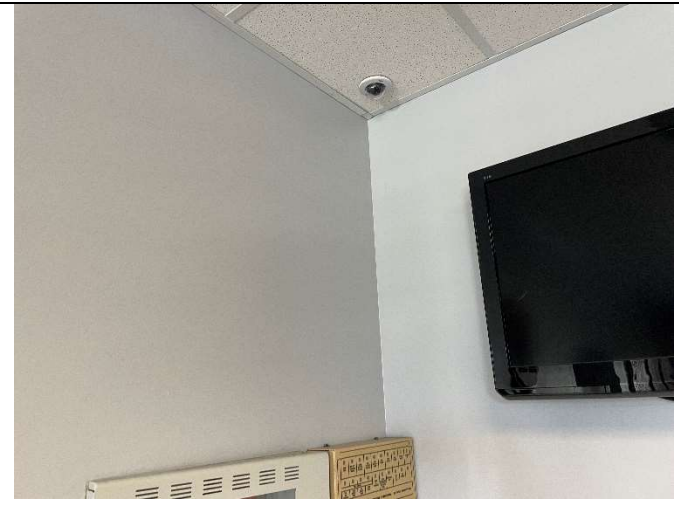
Photo 2: HM-A: Drywall/Joint Compound, White

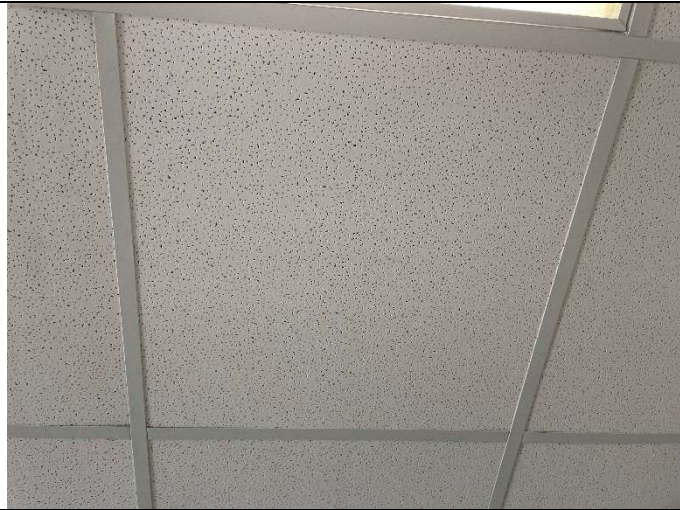
Photo 3: HM-B: 2' x 2' Ceiling Tile, White Pinhole

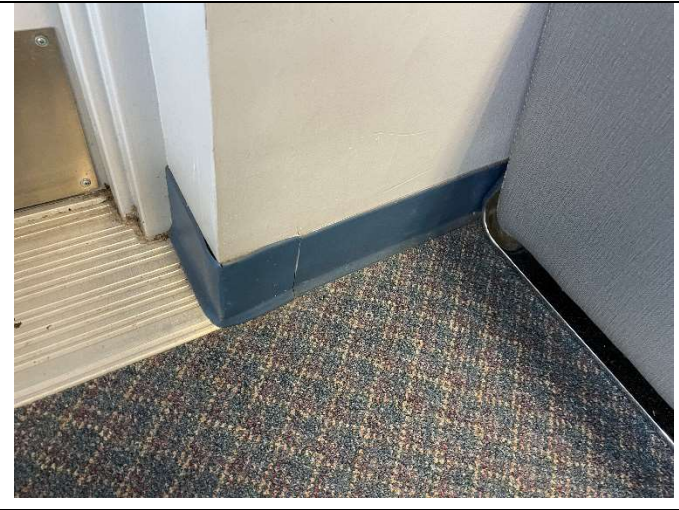
Photo 4: HM-C: Cove Base/Mastic, Navy Blue

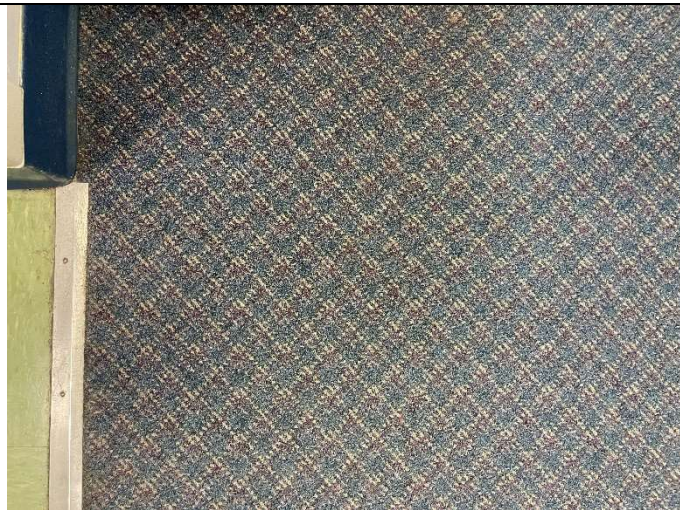
Photo 5: HM-D: Carpet Mastic, Yellow

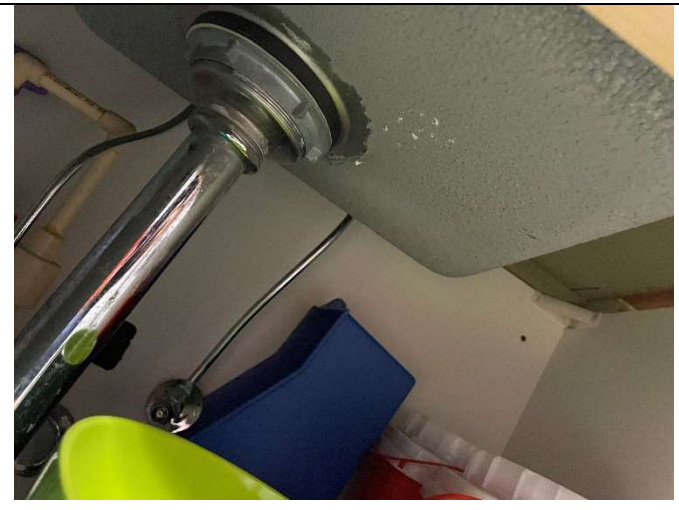
Photo 6: HM-E: Sink Insulation, Gray

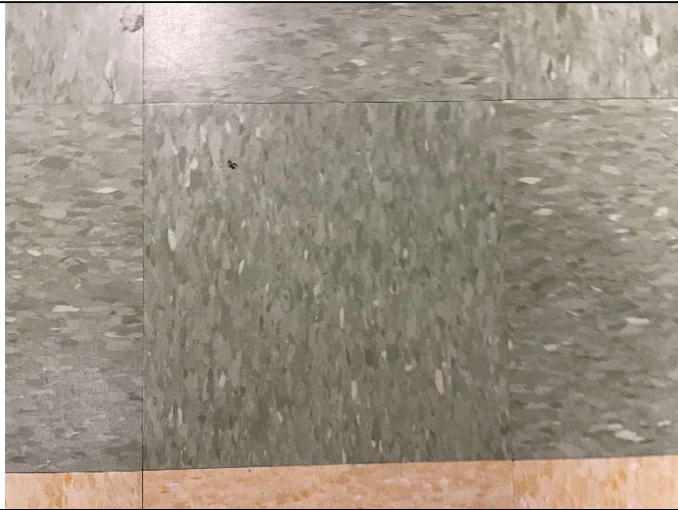
Photo 7: HM-F: 12" x 12" Vinyl Floor Tile, Green

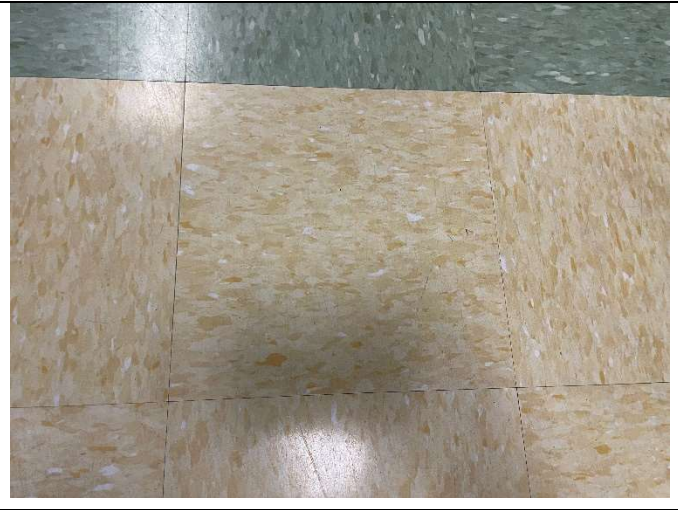
Photo 8: HM-G: 12" x 12" Vinyl Floor Tile, Tan

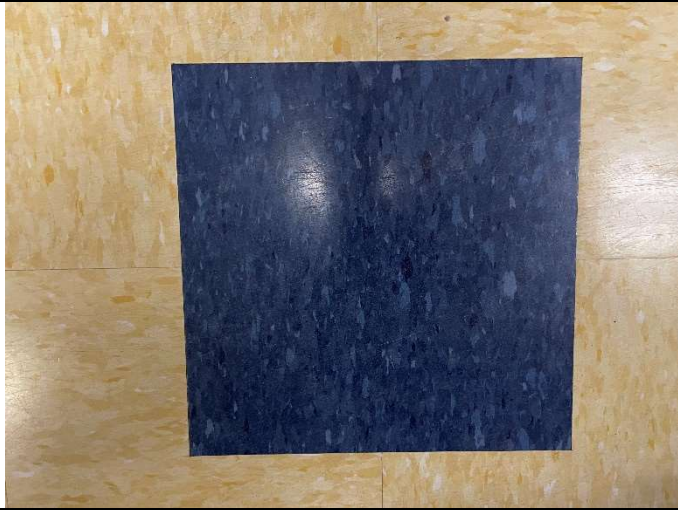
Photo 9: HM-H: 12" x 12" Vinyl Floor Tile, Navy Blue

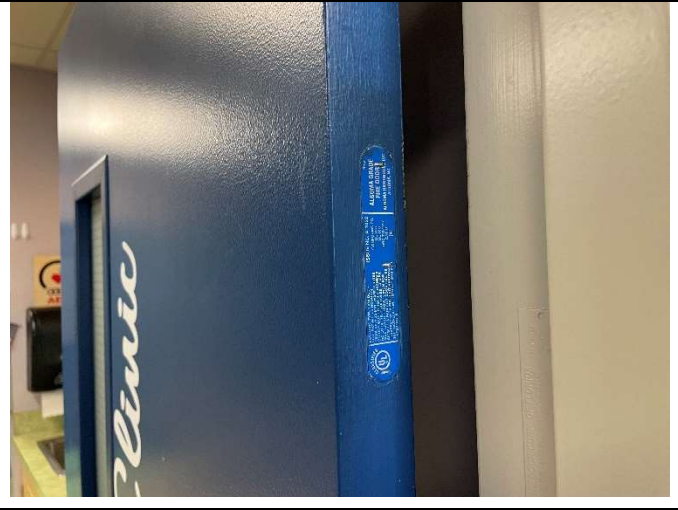
Photo 10: HM-I: Fire-rated Door Insulation, Blue Tag with Silver Lettering

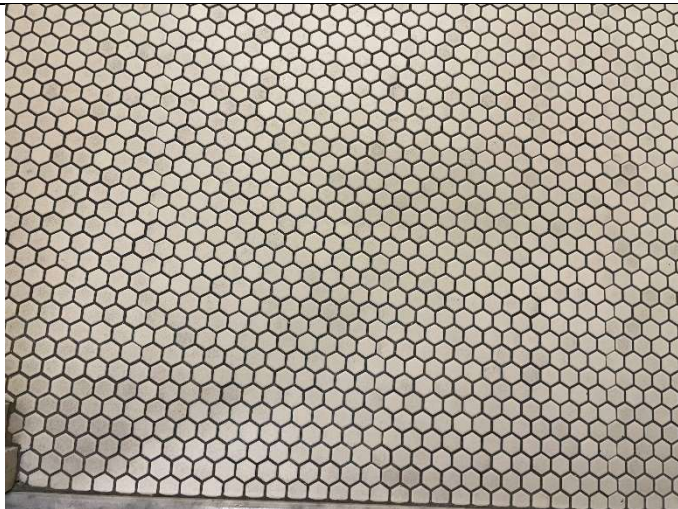
Photo 11: HM-J: Hexagon Ceramic Tile, White

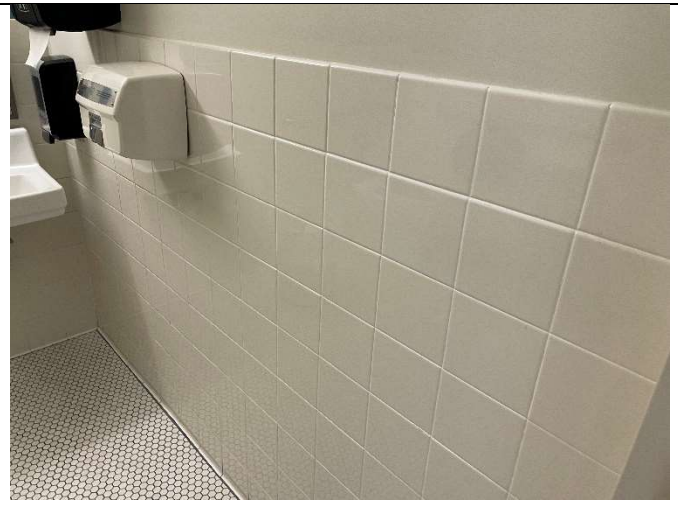
Photo 12: HM-K: 6" Ceramic Tile, White

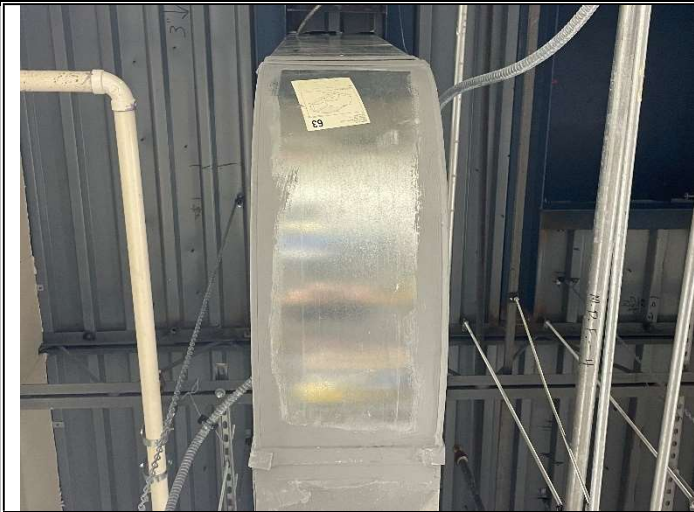
Photo 13: HM-L: Duct Mastic, Gray

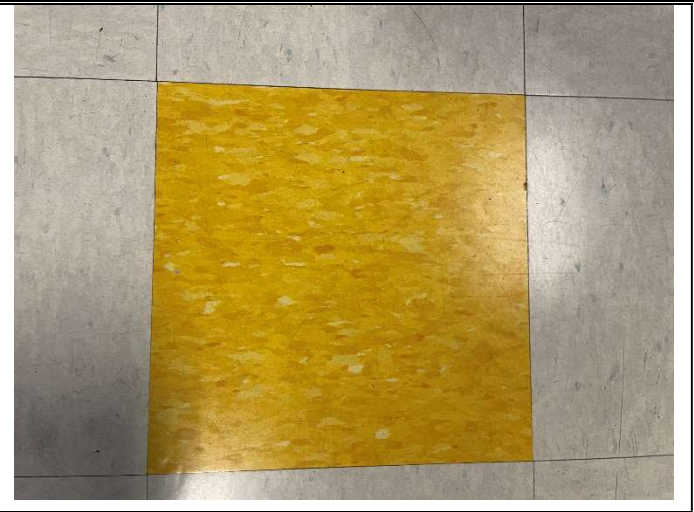
Photo 14: HM-M: 12" x 12" Vinyl Floor Tile, Yellow

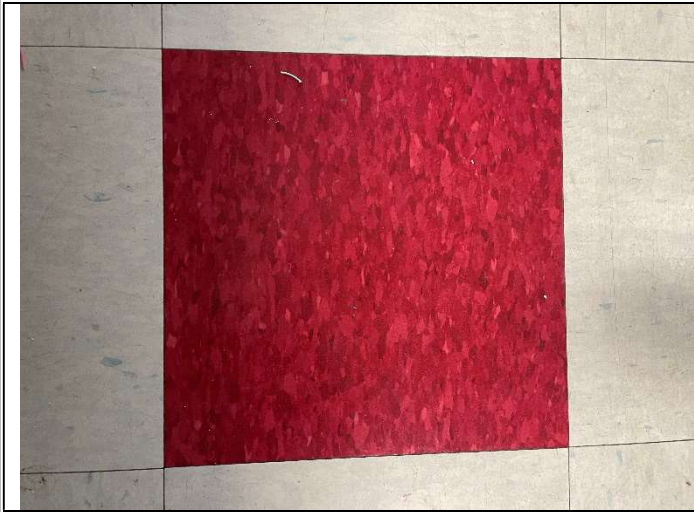
Photo 15: HM-N: 12" x 12" Vinyl Floor Tile, Red

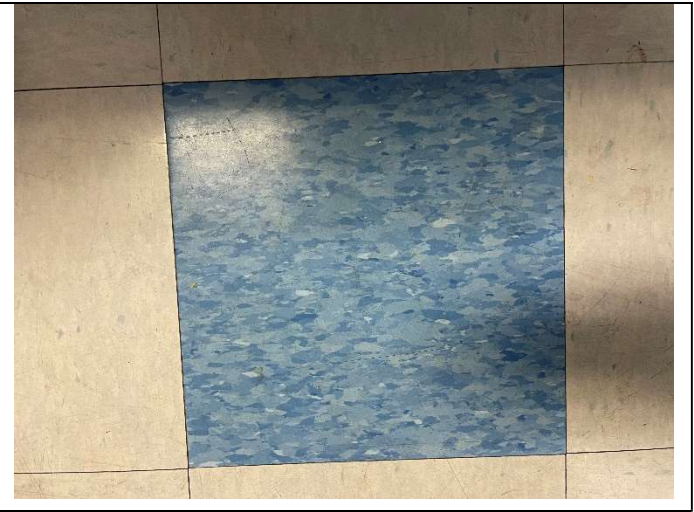
Photo 16: HM-O: 12" x 12" Vinyl Floor Tile, Light Blue

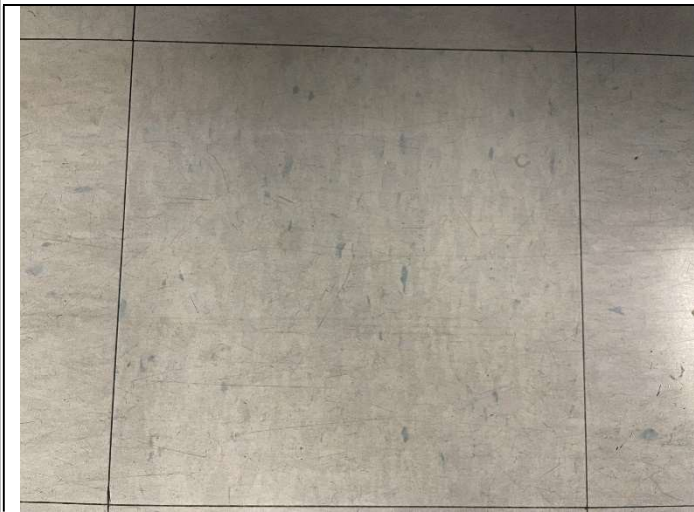
Photo 17: HM-P: 12" x 12" Vinyl Floor Tile, White with Blue Speckled

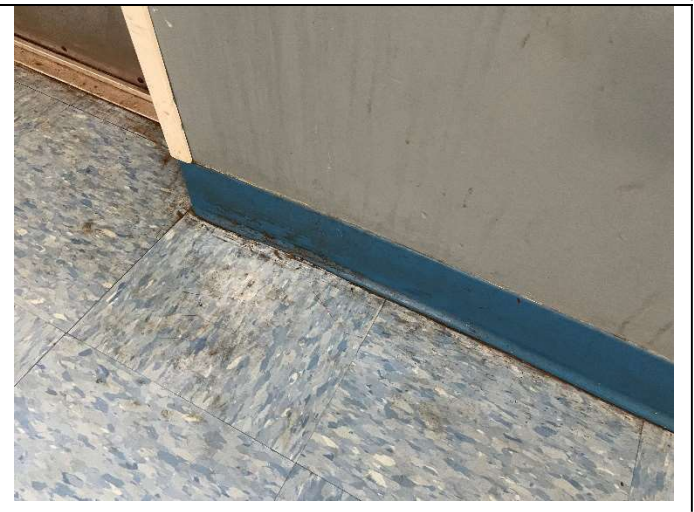
Photo 18: HM-Q: Cove Base/Mastic, Royal Blue

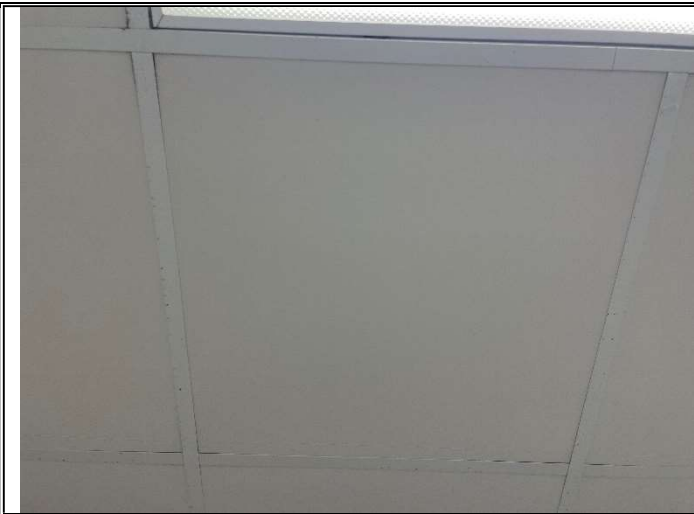
Photo 19: HM-R: 2' x 2' Drywall Ceiling Tile, White

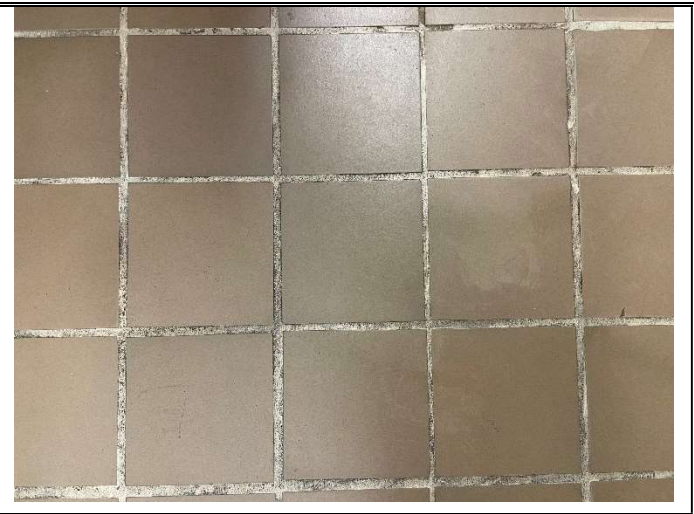
Photo 20: HM-S: 4" Ceramic Tile, Brown

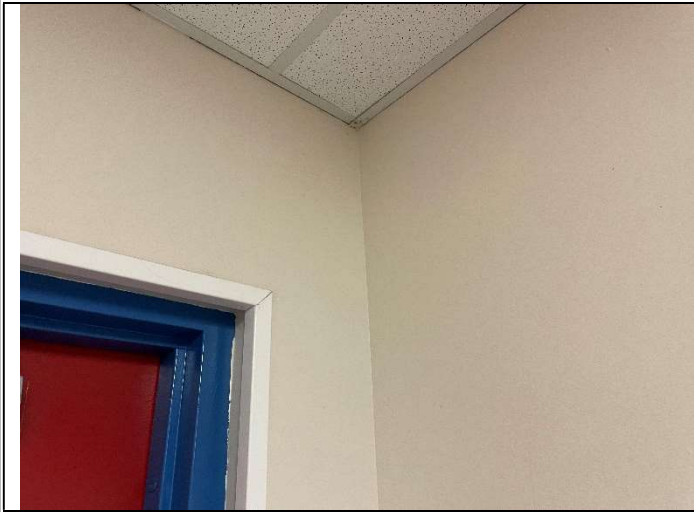
Photo 21: HM-T: Drywall/Joint Compound, White

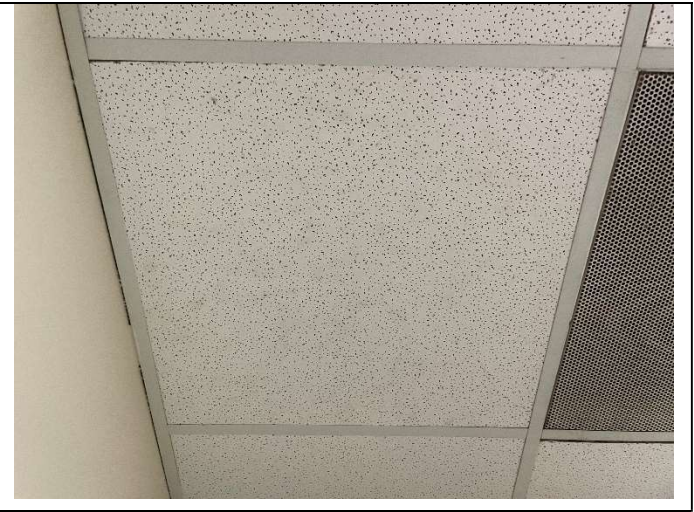
Photo 22: HM-U: 2' x 2' Ceiling Tile, White Pinhole

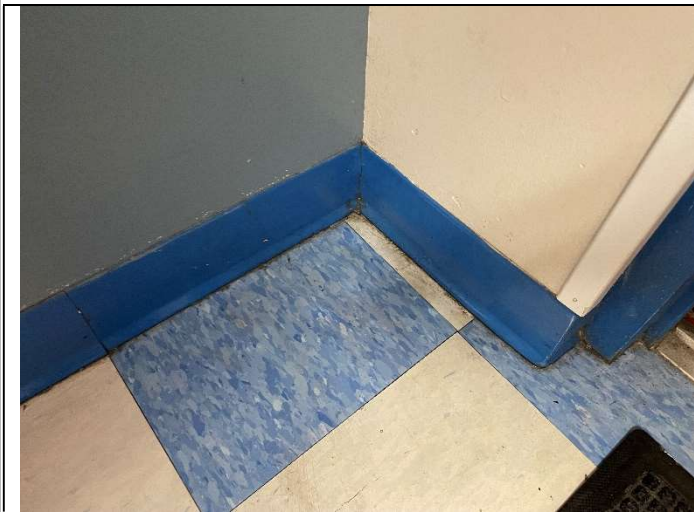
Photo 23: HM-V: Cove Base/Mastic, Royal Blue

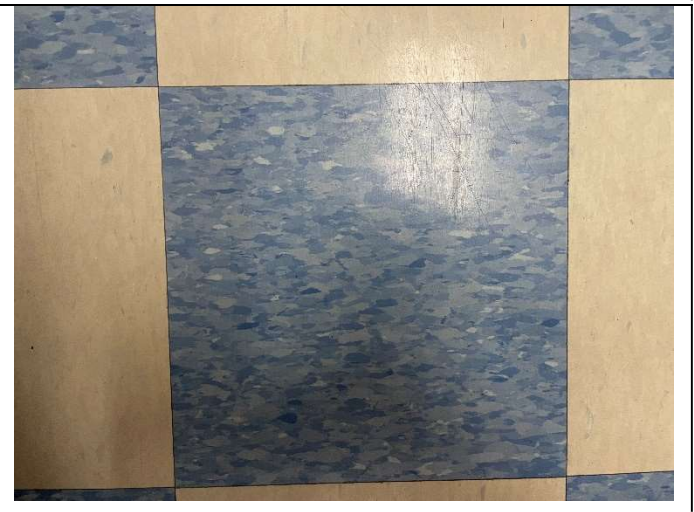
Photo 24: HM-W: 12" x 12" Vinyl Floor Tile, Blue

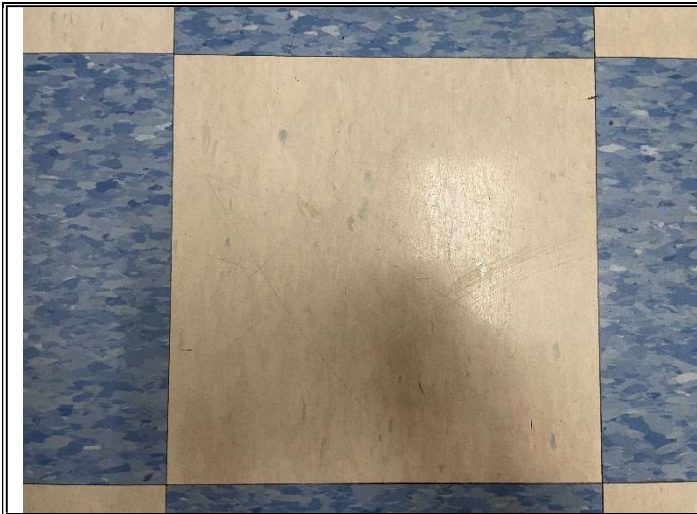
Photo 25: HM-X: 12" x 12" Vinyl Floor Tile, White with Blue Streaks

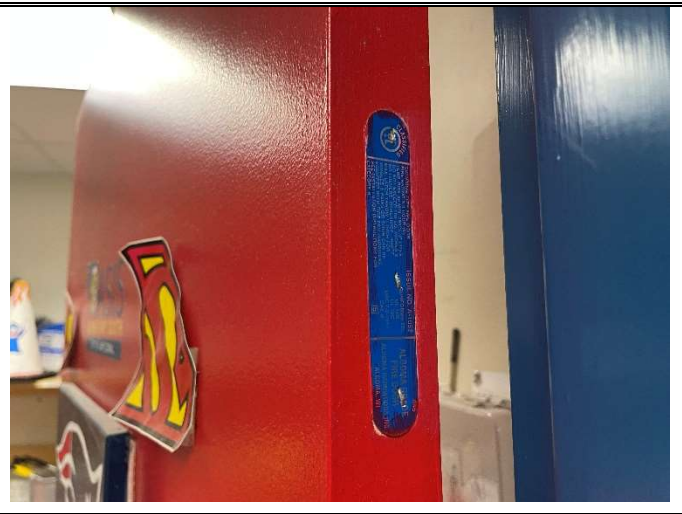
Photo 26: HM-Y: Fire-rated Door Insulation, Blue Tag with Silver Lettering

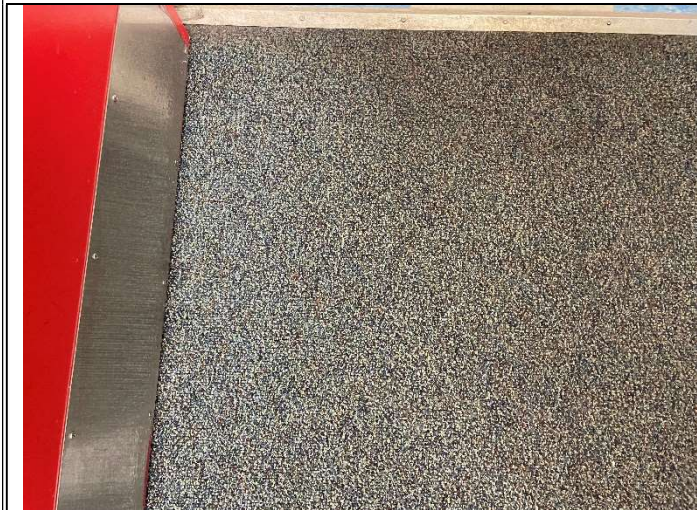
Photo 27: HM-Z: Carpet Mastic, Yellow

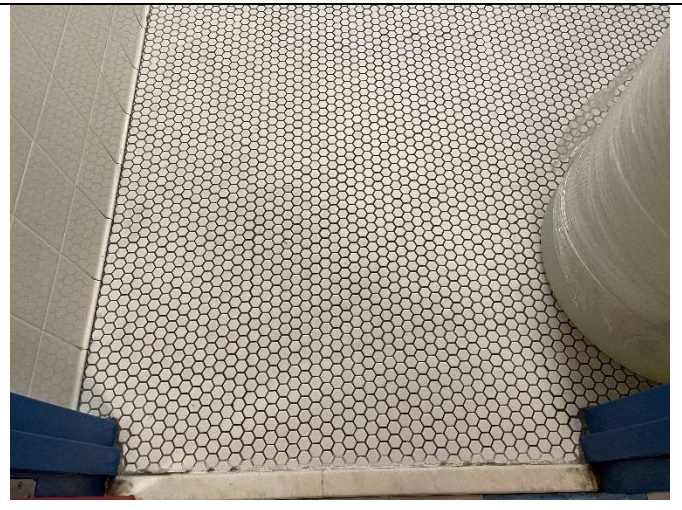
Photo 28: HM-AA: Hexagon Ceramic Tile, White

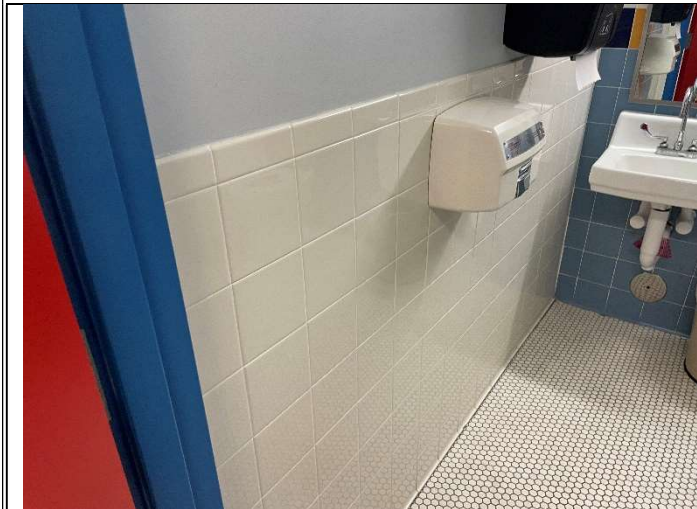
Photo 29: HM-BB: 4" Ceramic Tile, White

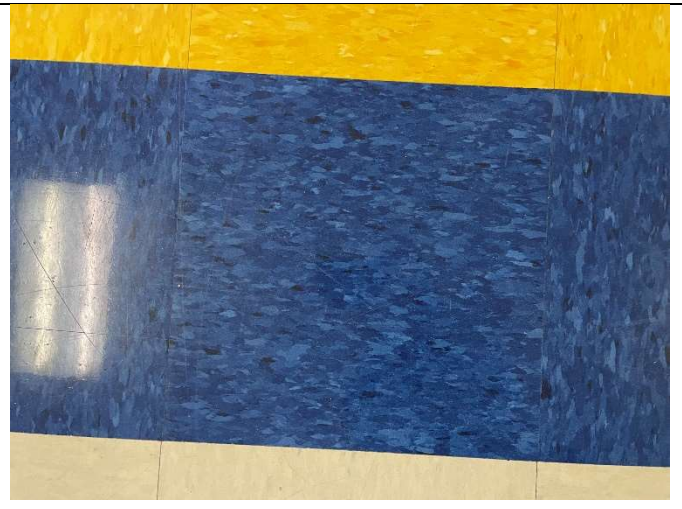
Photo 30: HM-CC: 12" x 12" Vinyl Floor Tile, Navy Blue

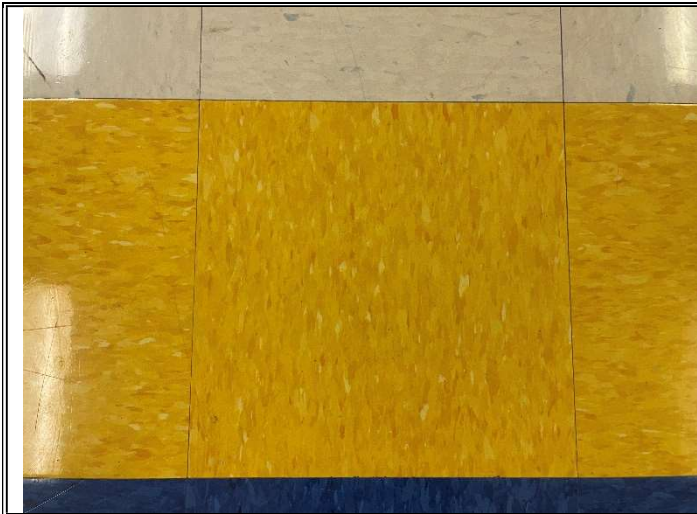
Photo 31: HM-DD: 12" x 12" Vinyl Floor Tile, Yellow

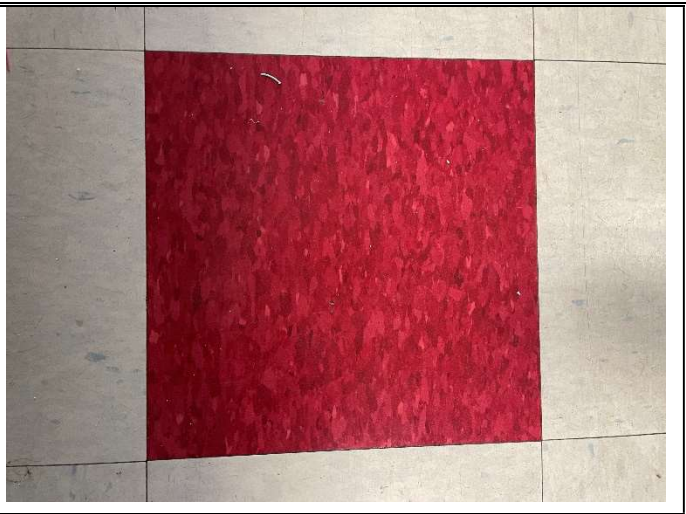
Photo 32: HM-EE: 12" x 12" Vinyl Floor Tile, Red

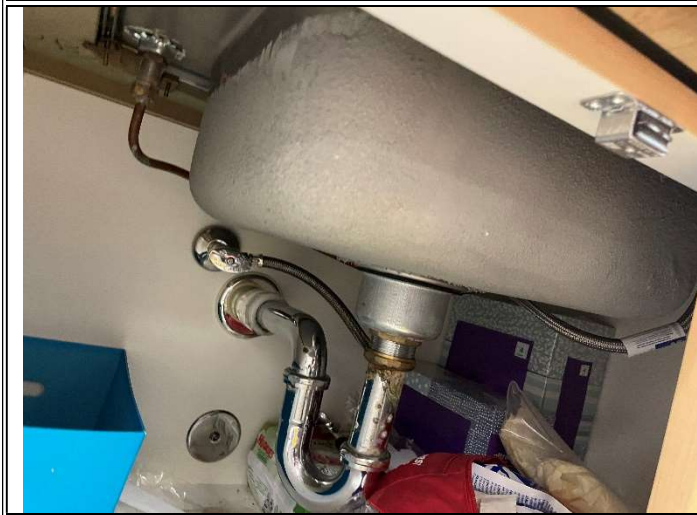
Photo 33: HM-FF: Sink Insulation, Gray

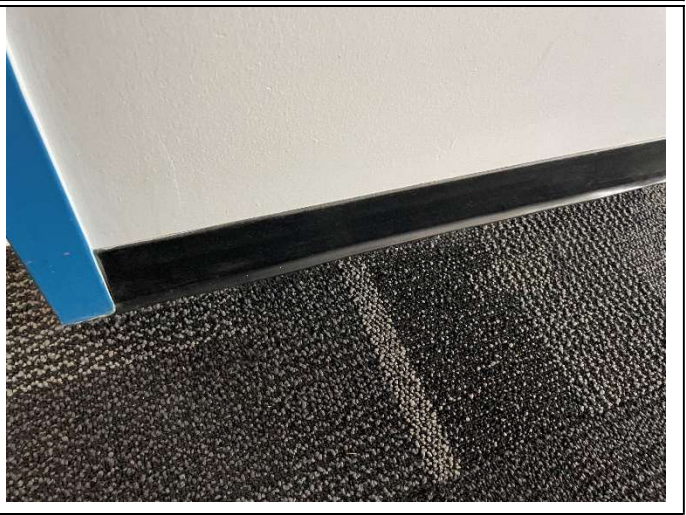
Photo 34: HM-GG: Cove Base/Mastic, Black

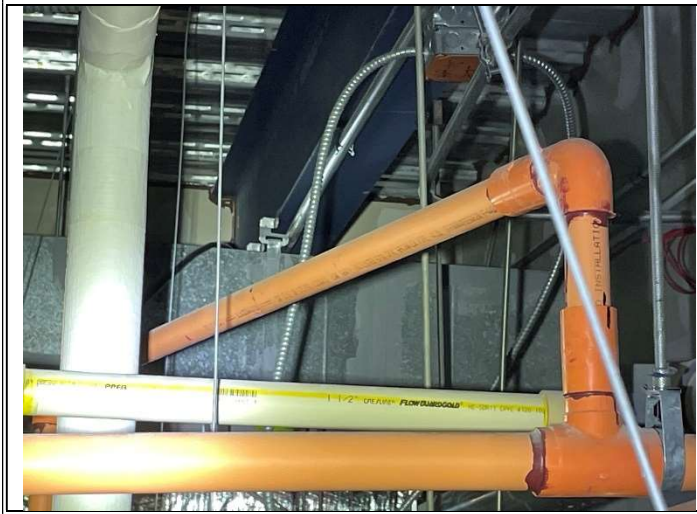
Photo 35: HM-HH: Duct Mastic, Gray
